Manhole Inspection Summary

Manhole # S41WW_008MH

Insp Date: **2/16/07 1:10 PM**

Location Address: **3212 LOCH RAVEN BLVD**

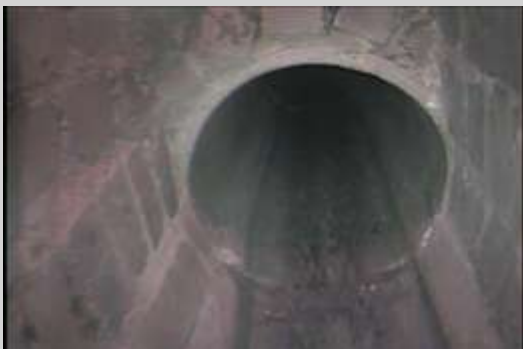
10 in. Circular Gravity Sewer Pipe In @ 6 O'Clock

Rod and Bar (Angled)

Pipe Material: **Clay** ☐ Pipe Lined

Infiltration: **None** Pipe Seal Cond: **Unknown**
